RESEARCH MEMORANDUM

PERFORMANCE OF AS-FORGED, HEAT-TREATED, AND OVERAGED

S-816 BLADES IN A TURBOJET ENGINE

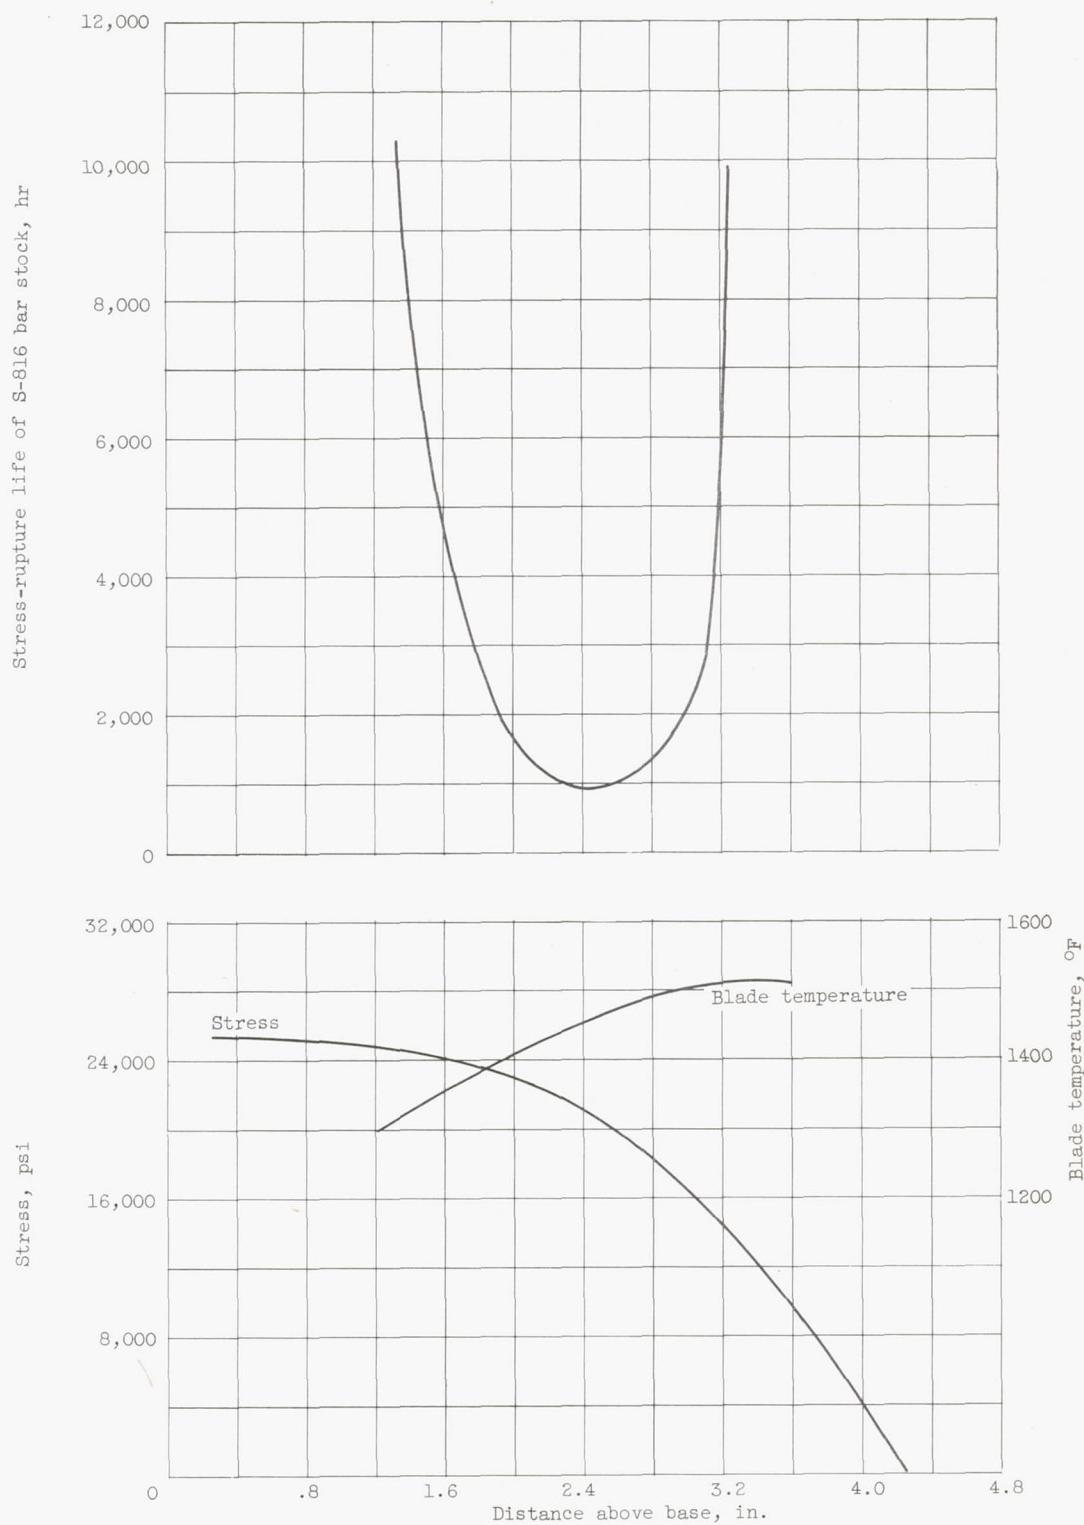
Stress and temperature distribution in turbine blades during engine operation. - The cross-sectional areas of J33-33 turbojet-engine blades were obtained from blueprints of the blade, and the distribution of centrifugal stress along the length of the blades was calculated by the method described in reference 4. Six thermocouples were welded to the midchord of the blade airfoils at different distances from the blade base, and a trial run in a J33-33 engine was made to determine the temperature distribution in this type of blade. Previously, J33-9 engine blades had been investigated for temperature distributions, and the method used for the J33-33 engine blades is essentially the same (ref. 5). Figure 1 shows the measured temperature and the calculated centrifugal-stress distributions for these blades during engine operation at full power as well as the stress-rupture life of S-816 bar stock at the different combinations of stress and temperature in the blades. The latter curve shows that the most severe combination of constant stress and temperature (21,400 psi and 1450° F, respectively) occurs at a distance

Figure 1. - Stress and temperature distribution in J33-33 turbine blades operated at full power and corresponding stress-rupture life of S-816 bar stock.

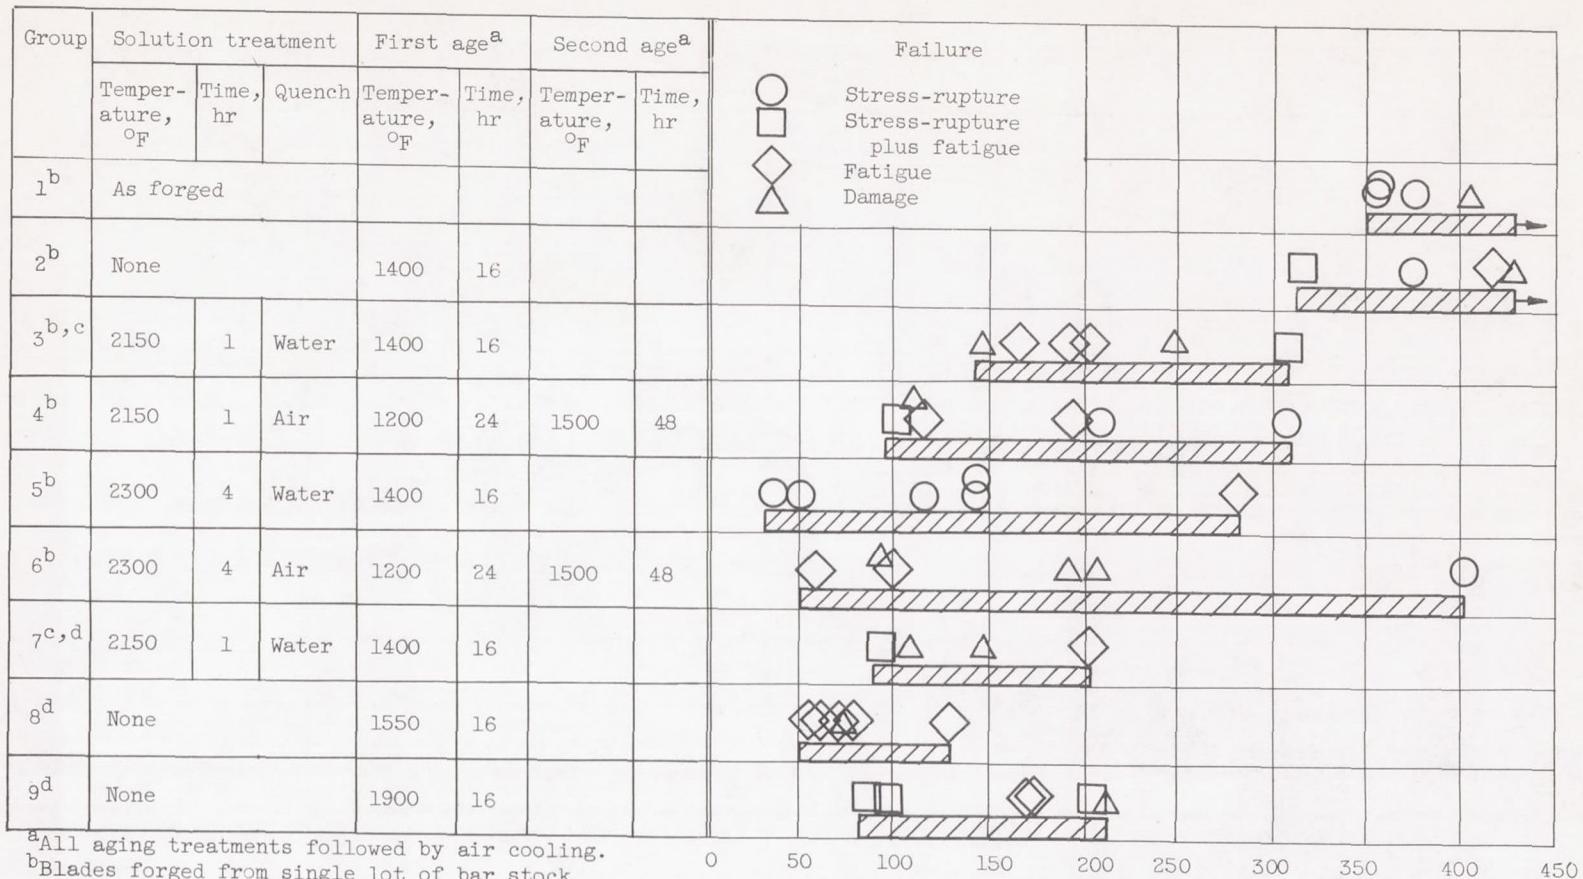
In order to facilitate the presentation of results as well as the subsequent discussion, the blade data are plotted in figure 2. The as-forged group of blades (group 1) performed at least twice as well as the group given the standard heat treatment (group 3). The blades of group 2, which were aged at 1400° F only, behaved essentially the same as the blades of group 1. The failure mechanisms of all blades in groups 1 and 2 were either stress-rupture or stress-rupture followed by fatigue, whereas the blades of group 3 failed chiefly from fatigue.

Figure 2. - Blade performance of J33-33 turbine blades of as-forged and heat-treated wrought S-816.

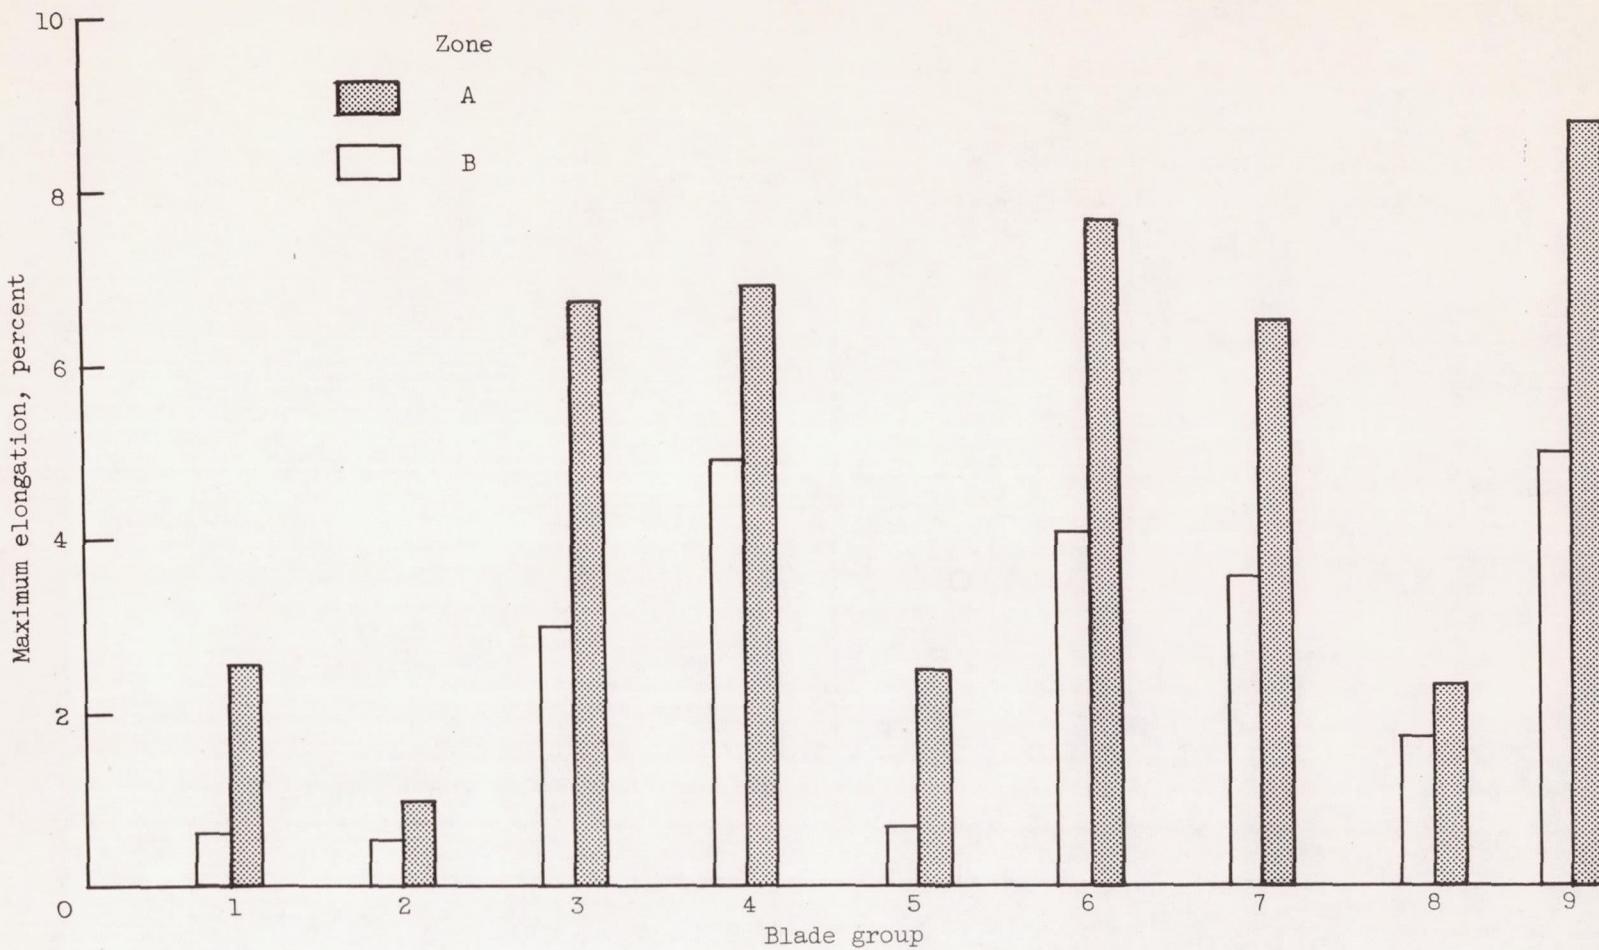
Elongation of blades during engine operation. - Elongation results are given in figure 3 for zone A. Elongation curves for zone B are not shown, but the maximum elongations measured in both zones are compared in figure 4.

Figure 4. - Maximum percent elongation measured for segments of blades extending from $1\frac{7}{8}$ to $2\frac{7}{8}$ inches from base (zone A) and from $7/8$ to $1\frac{7}{8}$ inches from base (zone B).

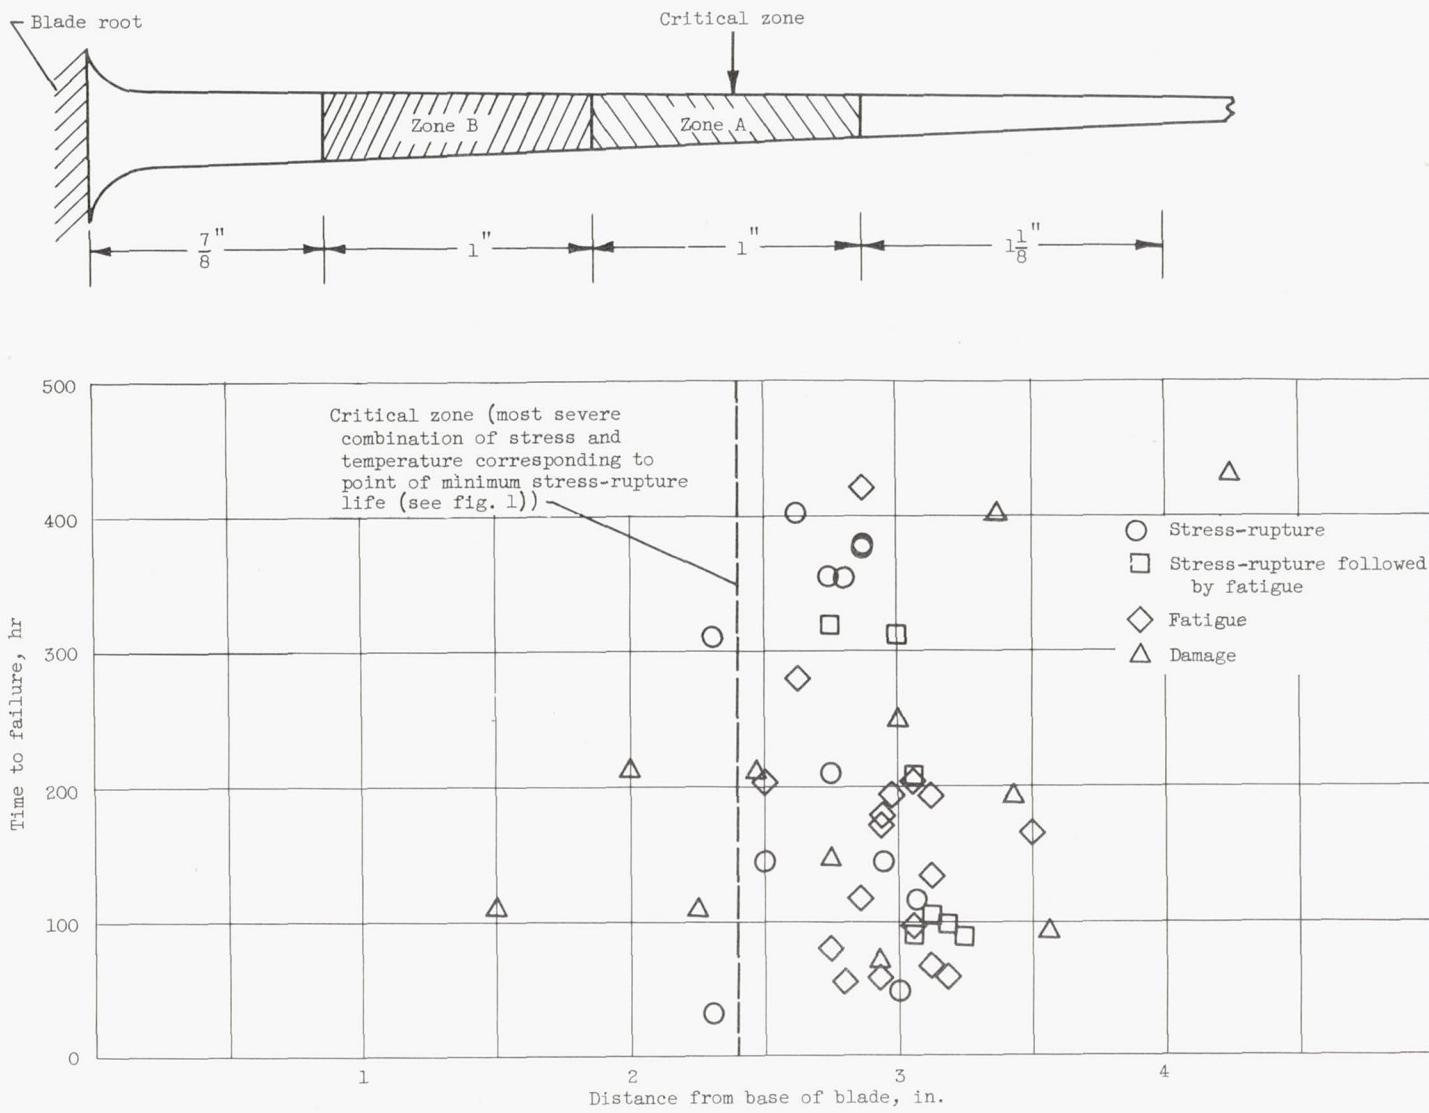
Figure 5. - Location of failure origins in blades.

Macroexaminations of failed blades. - Most of the blade failures (71 percent) occurred between $2\frac{5}{8}$ and $3\frac{1}{4}$ inches from the blade root platform as shown in table III and figure 5. This zone is farther from the base of the blade than the critical zone (defined by stress-rupture considerations), which was found to be 2.4 inches from the base. Of the total number of blade failures, 39 percent occurred in the segment for which elongation measurements were made and plotted (zone A), whereas 56 percent of the failures occurred above zone A.

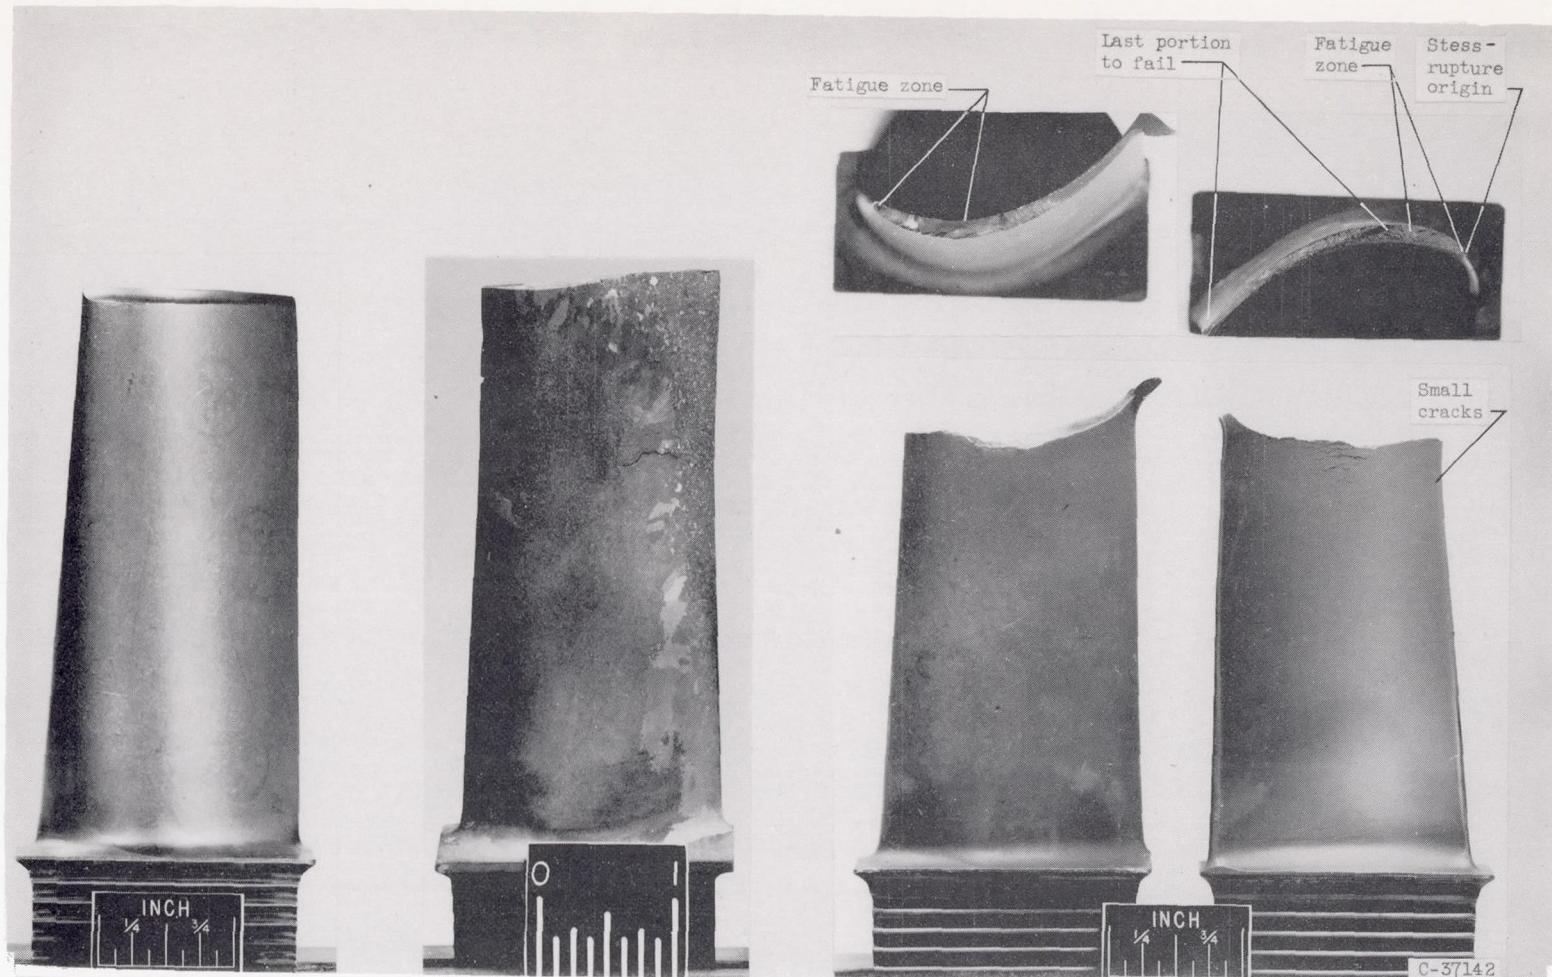
Figure 6. - As-forged blade and typical failed blades.

Photographs of typical "failed" and "unfailed" blades are shown in figure 6. The cracked blade contains typical stress-rupture cracks in the center of the blade; the blade which failed by fatigue contains the progression lines typical of a fatigue zone; and the stress-rupture followed by fatigue failure has some cracks below the fatigue zone, the criterion for this type of failure. Of the total number of failures other than damage failures, approximately 35 percent were classified as stress-rupture, 20 percent as stress-rupture followed by fatigue, and 45 percent as fatigue failures.

(a) As-forged. (b) Typical stress-rupture crack. (c) Typical fatigue failure. (d) Typical stress-rupture followed by fatigue failure.

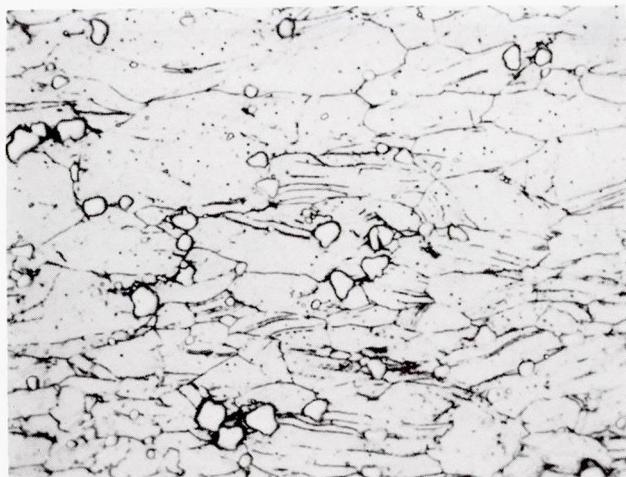
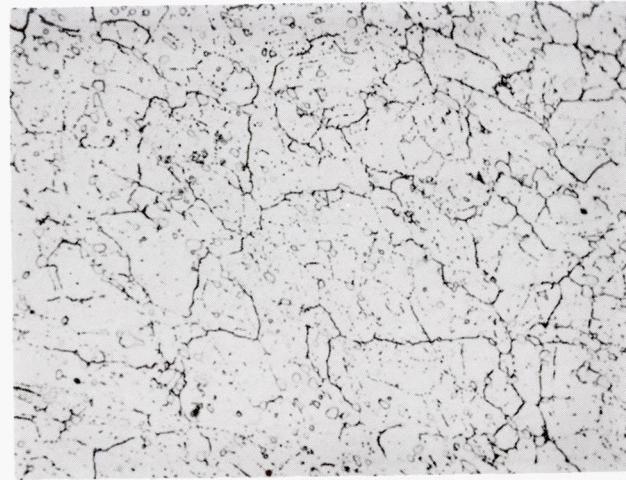
(a) Group 1 (as-forged).

Microstructure. - The microstructures of test pieces which were cut from representative blade segments and given the same heat treatment as the blade groups run in the engine are shown in figure 7. Metallographic specimens cut from a single as-forged blade were found to contain areas with elongated or severely distorted grains (fig. 7(a), left) as well as areas of equiaxed grains (fig. 7(a), right). The grain sizes observed were very small in the elongated areas (A.S.T.M. 8) and slightly larger in the equiaxed areas (A.S.T.M. 5 to 8). Precipitation in slip lines may be observed in the photomicrographs shown, but other areas appeared to have been partially solution treated. Elongated grains were most prominent near leading and trailing edges, while equiaxed grains were predominant at the center of the blade airfoil. The structure of the specimen aged at 1400° F for 16 hours (fig. 7(b)) shows an area with equiaxed grains similar to the area of equiaxed grains shown in figure 7(a), with precipitation in slip lines and twin and grain boundaries. The specimen given the standard heat treatment for S-816 contains the usual massive residual columbium carbides (probably $(Cb,Ta)C$) and fine precipitation in the grain boundaries. General precipitation in the matrix is not noticeable. The specimen given the standard solution treatment at 2150° F for 1 hour followed by double aging (fig. 7(d))

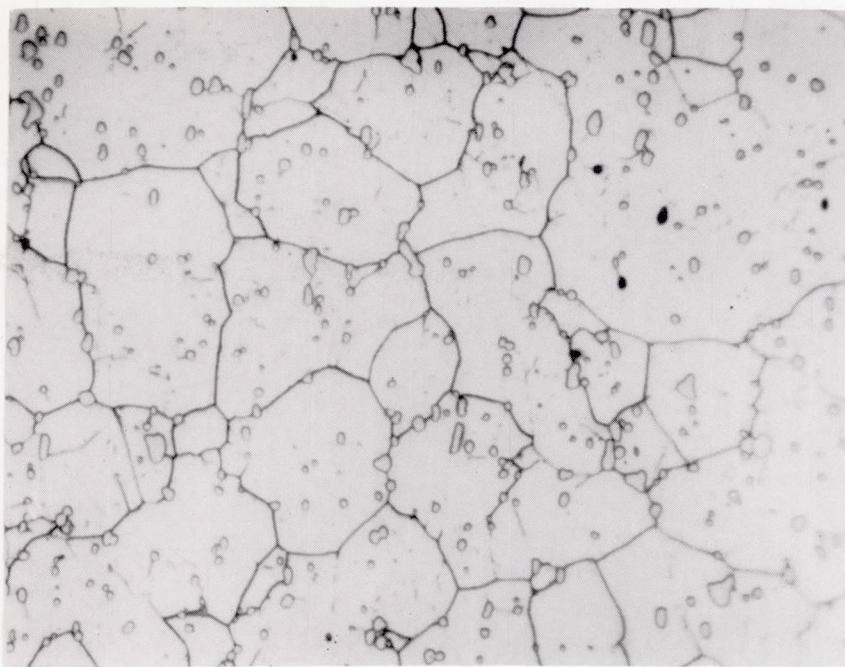
(c) Group 3 (standard heat treatment: 1 hr at 2150° F, water quenched, aged 16 hr at 1400° F, air cooled).

The structure of a typical Air Force stock blade is shown in figure 7(g) and is almost identical to that of figure 7(c), which represents the same condition of heat treatment. Upon overaging or overheating the Air Force stock blades at 1550° F for 16 hours, the precipitation in the grain boundaries appears to increase (fig. 7(h)) and a little matrix precipitation also has occurred. The specimen overheated at 1900° F for 16 hours (fig. 7(i)) shows that some of the carbides, particularly those in the grain boundaries, have spheroidized and that the matrix is relatively clean.

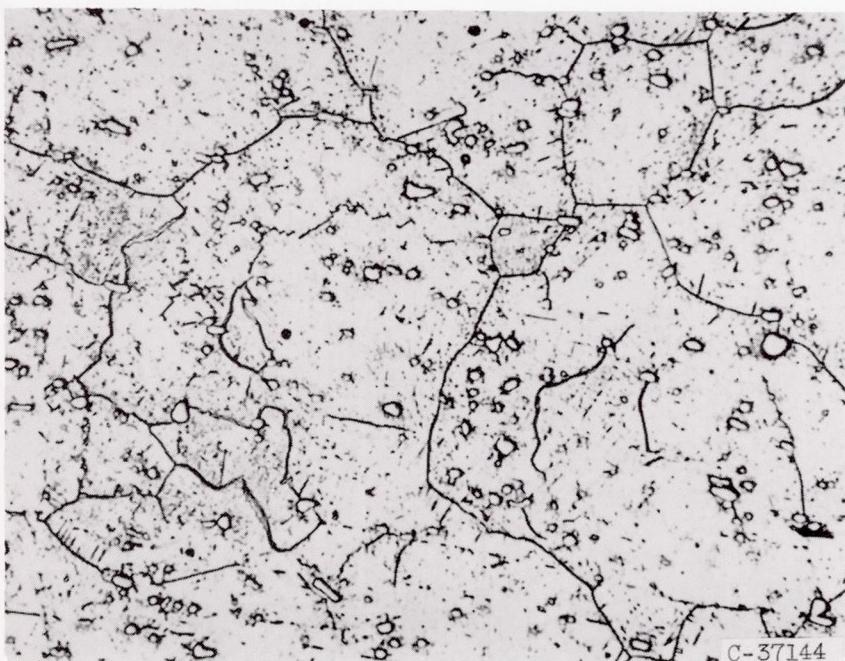
(d) Group 4 (1 hr at 2150° F, air quenched, aged 24 hr at 1200° F, air cooled, aged 48 hr at 1500° F, air cooled).

shows increased matrix precipitation and, of course, the residual carbides. The specimen given a solution treatment for 4 hours at 2300° F followed by the standard aging treatment (fig. 7(e)) has a structure essentially the same as that of the specimen given the standard heat treatment except that the average grain size is greater. Some of the larger carbides appear to be idiomorphic, indicating that at higher temperatures the carbide forming element (Cb or Ta) diffuses to the residual carbide sites and precipitates as a carbide upon the original carbide. In figure 7(f) the specimen solution treated at 2300° F followed by double aging shows very large grains with an unusually large quantity of matrix precipitation as well as a small quantity of Widmanstätten structure. Larger carbides also appear to be idiomorphic, as was the case in the preceding specimens.

In figure 8(d), the photomicrographs represent the group of specimens given the double age (group 4). Since the specimens treated in the same manner (fig. 7(d)) contained a considerable quantity of precipitation, it is surprising to note so little matrix precipitation in the first blade to fail. The matrix precipitation is beginning to spheroidize, and the grain boundaries contain enough carbides to be almost continuous. The structure of the last blade to fail corresponds more closely with the structure shown in figure 7(d). In figure 8(e) (group 5), the first failure, which occurred in an unusually short time (36 hr), contained a considerable quantity of eutectic melting and the stress-rupture cracks occurred in areas with considerable evidence of grain boundaries melting. This group of blades was solution treated at 2300° F. In the blade which failed last the grain boundaries were very thick (although this cannot be observed in the photomicrographs). This failure contained a formation similar to "Chinese script," which may be evidence of melting. In both the first and last failures, large quantities of precipitation have occurred in slip lines and in Widmanstätten patterns and are very extensive.

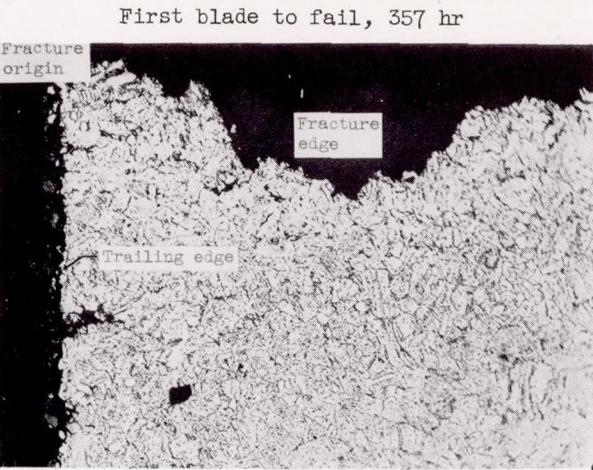
Tears below fracture edge and irregular fracture edge are indicative of stress-rupture failure mechanism.

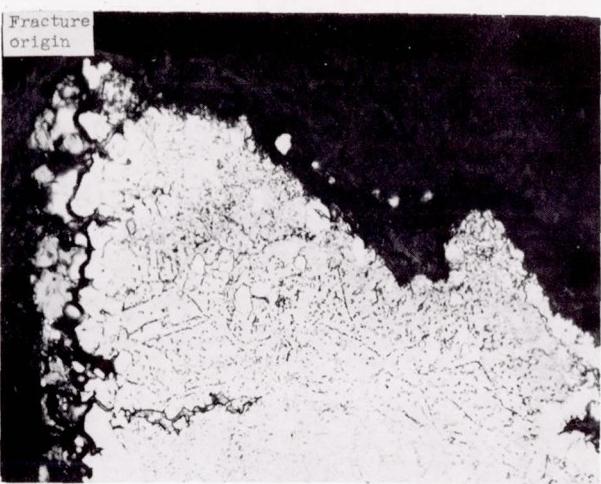
Oxide in intergranular crack below fracture edge. Area is same as at X100 except that specimen was repolished

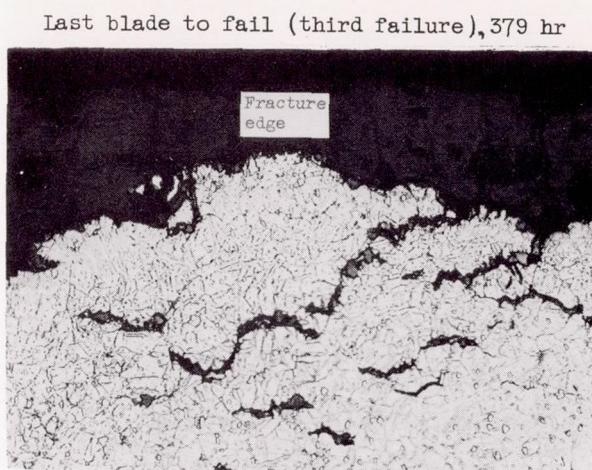
Typical stress-rupture tears in center portion of blade where failure originated.

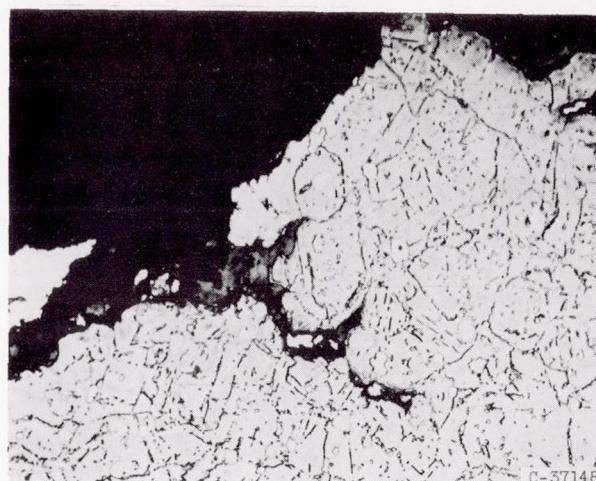
(a) Group 1.

Enlarged view of fracture edge.

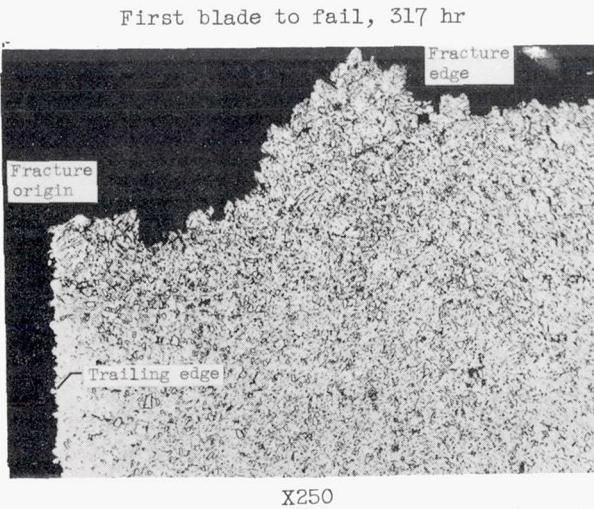
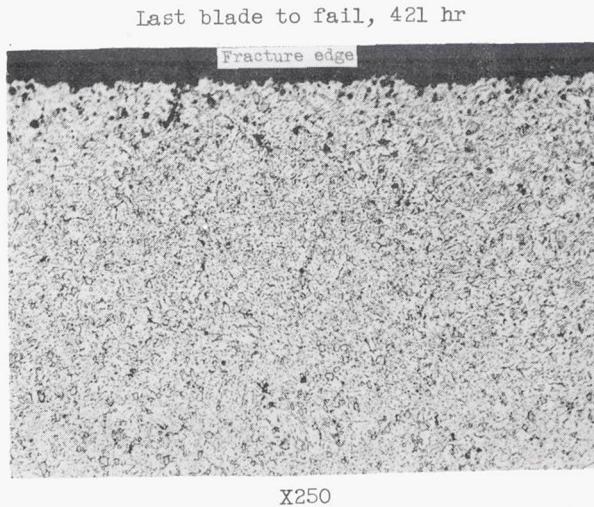
(b) Group 2.

Stress-rupture characteristics in form of tears and jagged edges. Fatigue originated 1/32 in. from edge. Fracture edge shown is in area of origin and appears smooth and straight.

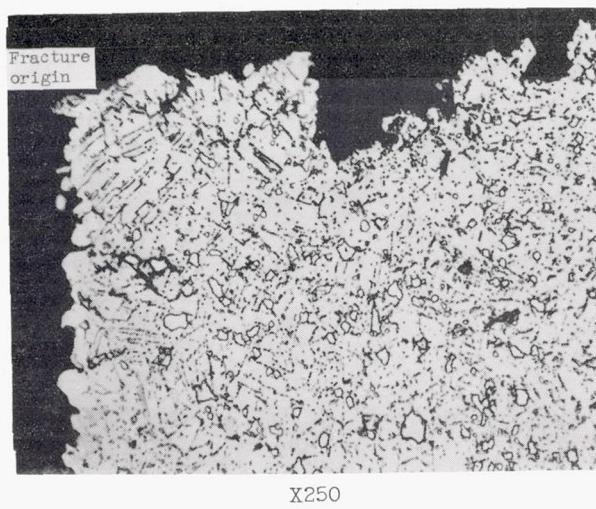
Same area as above.

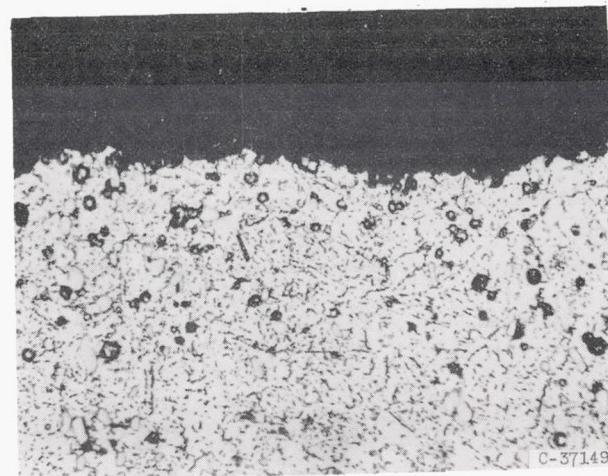
Same as above area. Fracture edge appears transcrystalline.

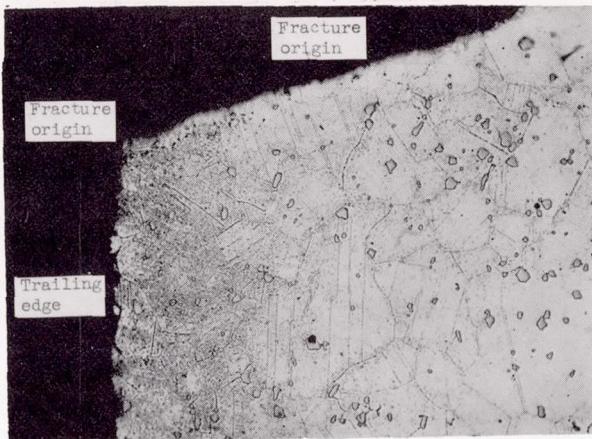
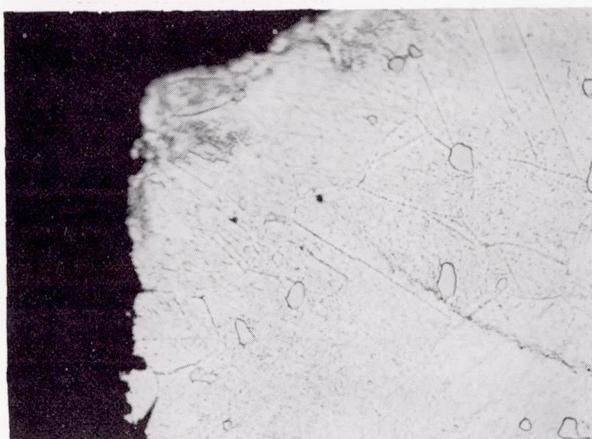
First blade to fail, 167 hr

In figure 8(c), the specimens given the standard heat treatment (group 3), the first failure is shown to have a smooth transcrystalline fracture edge, indicative of fatigue; and the last failure is shown to have stress-rupture characteristics, as shown by the jagged fracture edge and the stress-rupture cracks below the fracture edge. This confirms the classification of these specimens made in table III. The precipitation in the first failure is well developed, but since it has run only 167 hours, spheroidization has not taken place to a great degree. The microstructure of the last specimen to fail (failure time, 310 hr) shows, at high magnification, that the precipitation in the immediate vicinity of the fracture origin is to a large degree in a Widmanstätten form, that the precipitation in the grain boundaries is much more nearly continuous than those of the specimens of groups 1 and 2, and that the grain size near the fracture origin is greater than in groups 1 and 2. Any of these conditions could account for the poorer performance of this group of blades relative to groups 1 and 2.

Smooth transcrystalline nature of fracture edge,
which is indicative of fatigue.

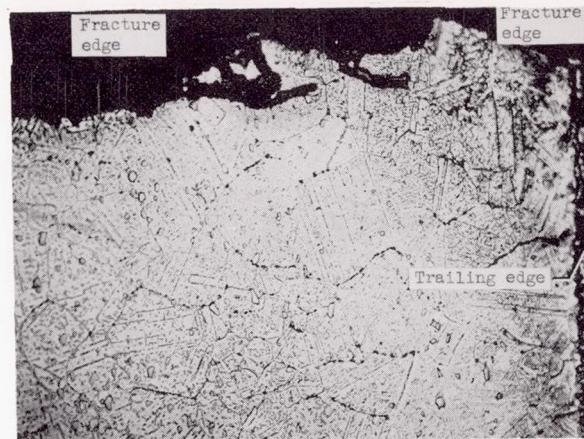
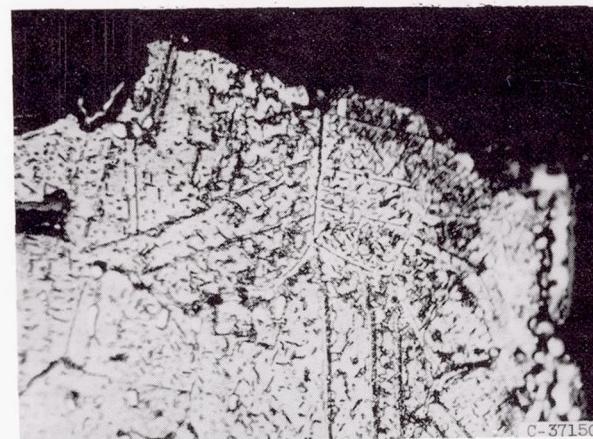
Last blade to fail, 310 hr

Jagged fracture edge and stress-rupture tears.

Same area as above. Fine Widmanst tten structure.

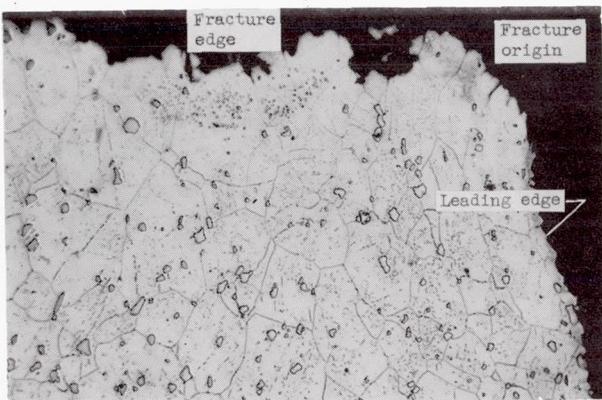
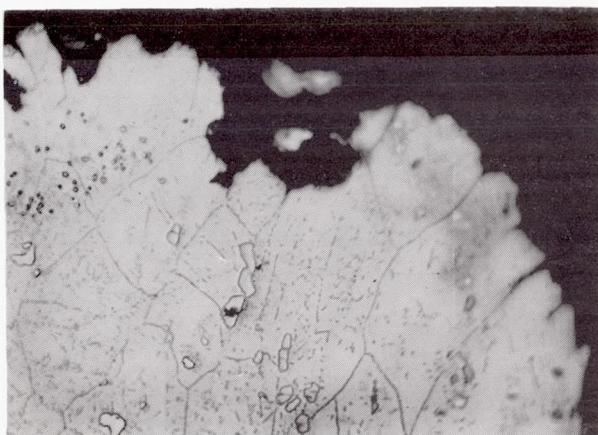
First blade to fail, 102 hr

Very little general precipitation in structure, which is not consistent with as-heat-treated structure of fig. 6(d). Jagged edge is indicative of stress-rupture failure. Dent on leading edge could have resulted after blade failed.

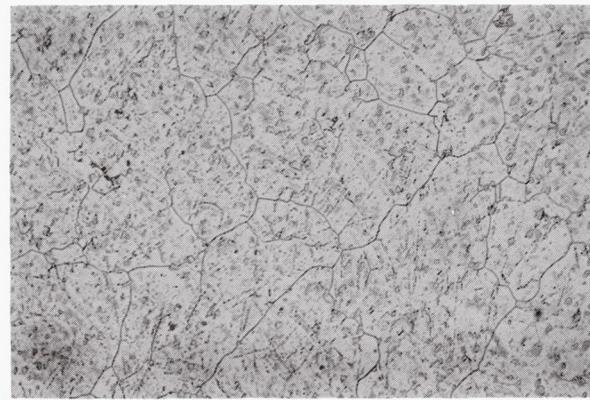
Last blade to fail, 310 hr

Stress-rupture crack was removed by polishing. Structure shown is in immediate area of crack which was present.

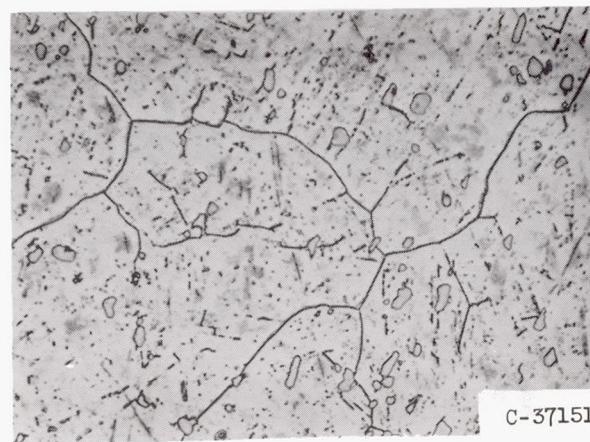
Large quantities of general matrix precipitation are evident.

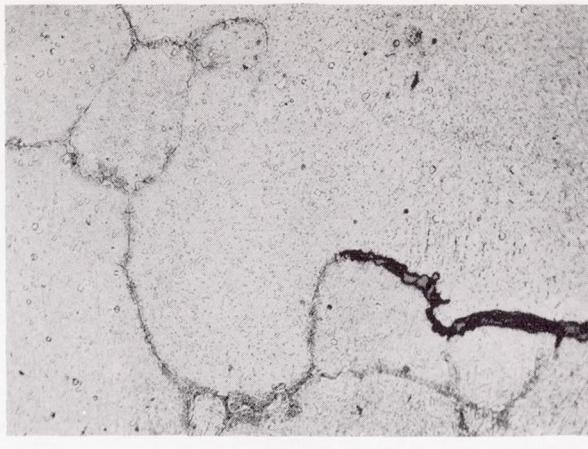
First blade to fail, 36 hr

Intergranular crack following grain boundary exhibiting
eutectic melting.

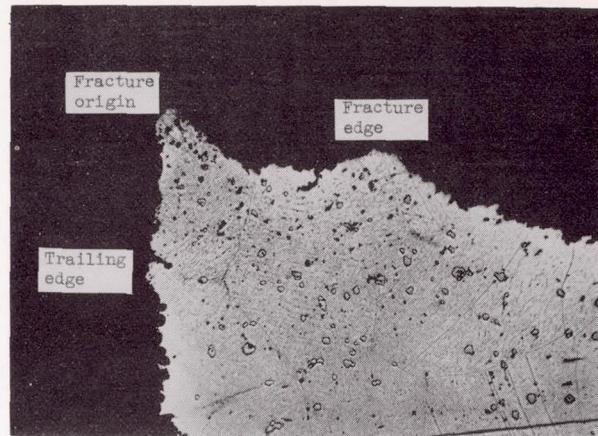
Last blade to fail, 285 hr

Fracture edge appears transcrystalline, indicative of fatigue.

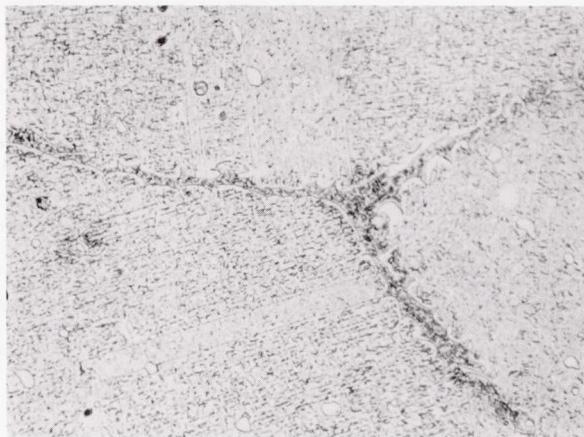
Eutectic melting in grain boundaries and rosette formations
are evident.

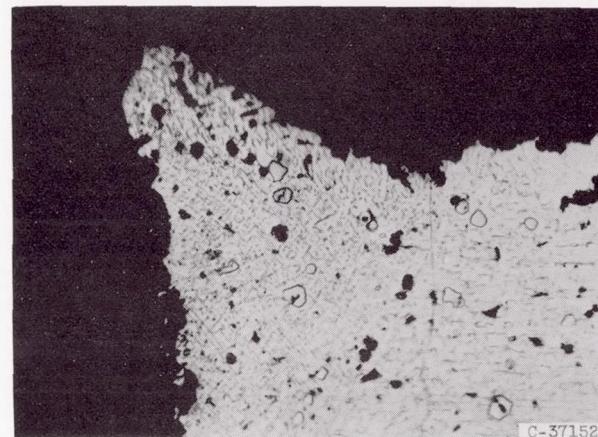
Grain boundaries contain thick precipitation. Voids could
be evidence of melting or etching effect.

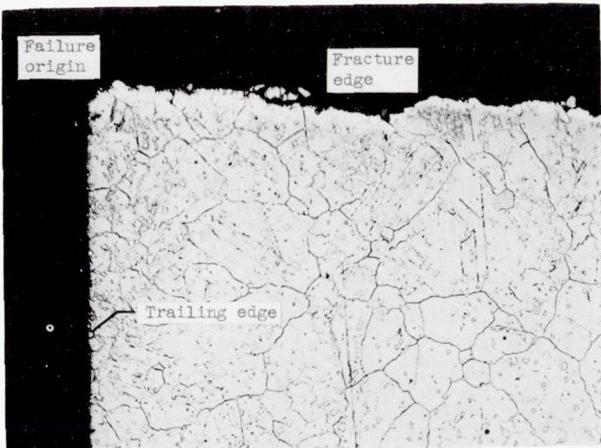
First blade to fail, 59 hr

Blades of group 6 were also solution treated at 2300° F but did not show new evidence of eutectic melting (fig. 8(f)). The photomicrograph of the first specimen to fail shows the area at or near the origin of the crack. The fracture edge is transcrystalline and smooth, indicative of fatigue. Again all the blades in this group were sectioned to determine whether any eutectic melting occurred, and nothing was found comparable with the evidence found in group 5. In one of the blades some possible Chinese script was found, but it was not extensive. In another blade, the fatigue crack was propagated across very fine grains and adjacent germinated grains without deviating from a straight path. The most deleterious formation observed in this group of blades consisted of thick carbide formations in grain boundaries.

Fracture edge is transcrystalline, indicative of fatigue.

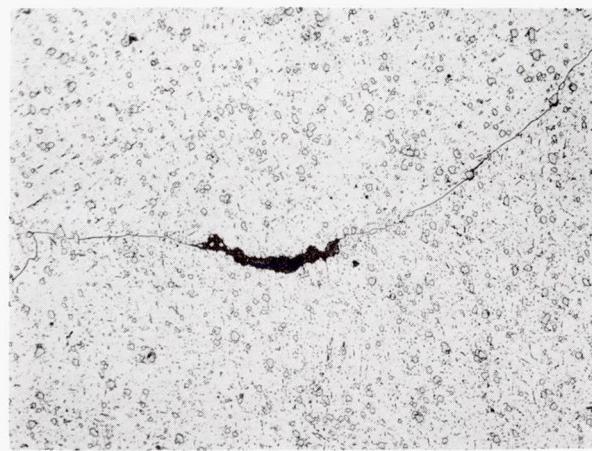
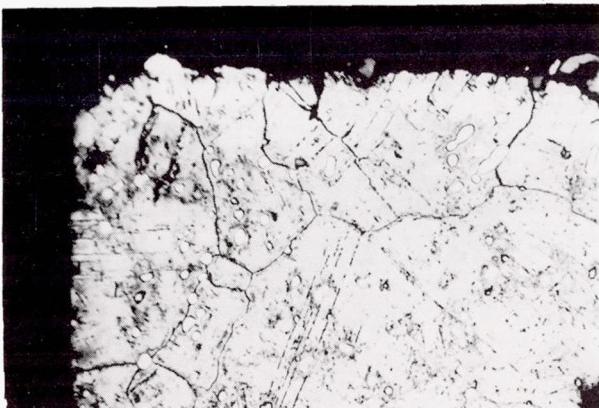
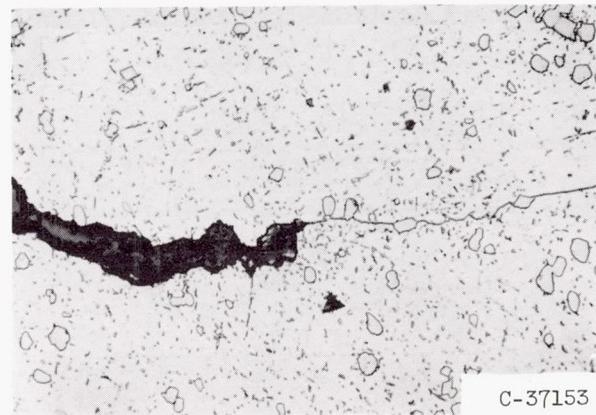
Last blade to fail, 401 hr

One of several stress-rupture cracks occurring in grain boundaries in center of blade airfoil.

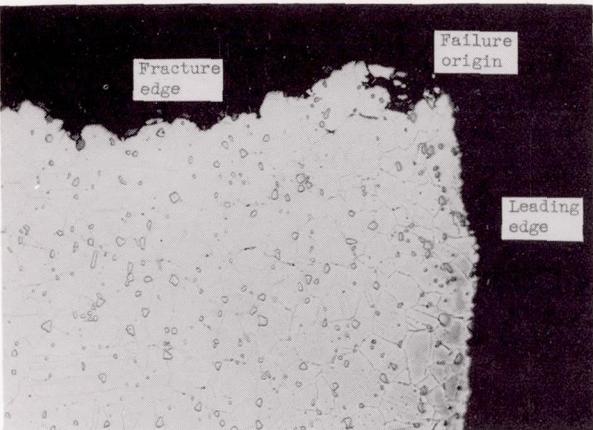
First blade to fail, 94 hr

The structures of Air Force stock blades given the standard heat treatment are shown in figure 8(g). There is a noticeable difference between the structures of the blade failures of this group and those of the blade failures of group 3, which also received the standard heat treatment. The Air Force stock blade which failed first has much less general precipitation than the specimens of group 3, and the first failure time is less. Grain boundary precipitates and residual carbides appear to be the same in both groups, but the grain size of the specimen of group 7 is finer than that of group 3. This could be the result of forging variables. An interesting but unexplainable happenstance is that all failures of group 3 originated at the trailing edges, whereas all failures of group 7 originated at the leading edges. Stress-rupture and fatigue characteristics are present in the photographs of the first and last failures, respectively.

X250
Stress-rupture characteristics of failure occur at jagged failure origin, irregular fracture edge, and intercrystalline tear.

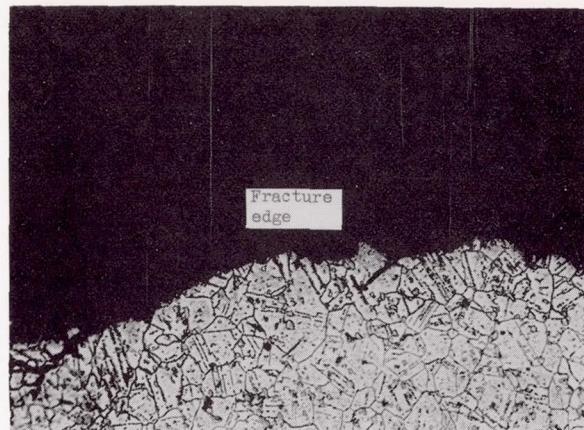
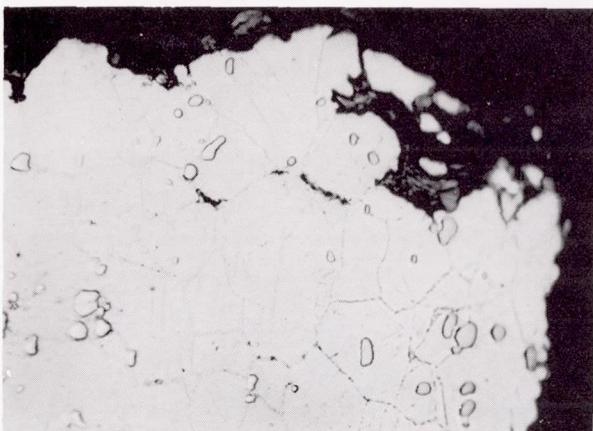
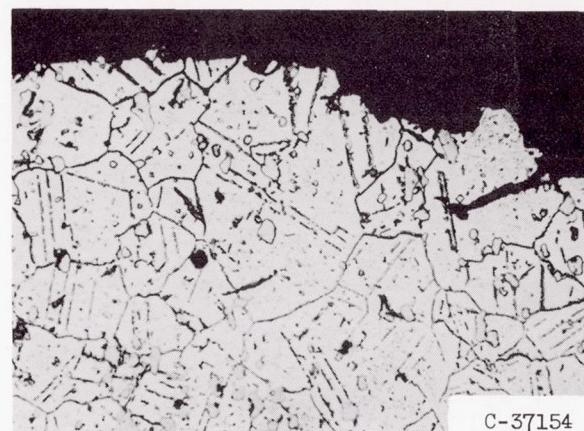
Last blade to fail, 202 hr

X250
Fracture originated 1/4 in. from leading edge and progressed in transcrystalline manner indicative of fatigue.

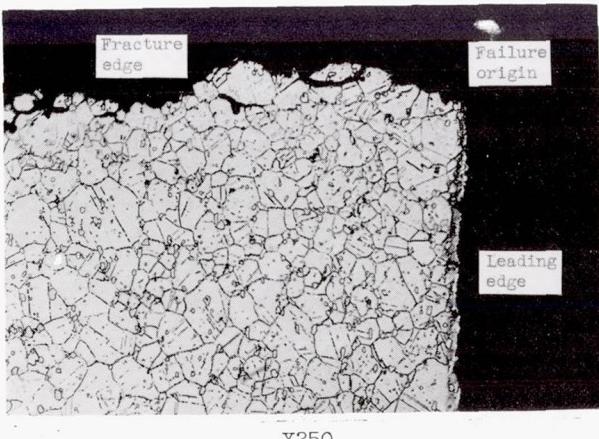
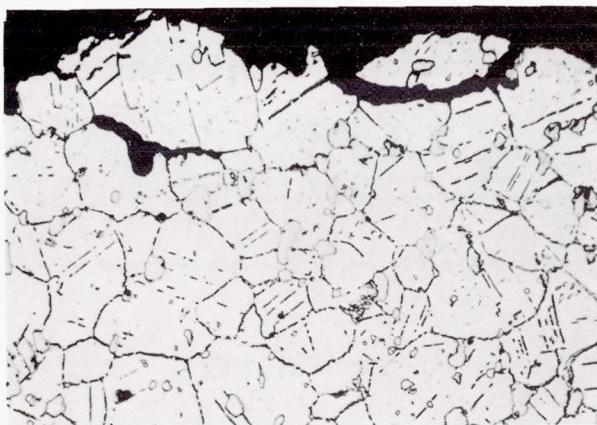
First blade to fail, 60 hr

The structures of failed blades which had been overaged (overheated) at 1550° F are shown in figure 8(h) (group 8). Carbides precipitated in the matrix, and slip lines and twin boundaries have been partially spheroidized. Matrix precipitation has not occurred to any great extent. The fracture edges of both specimens are predominantly transcrystalline, indicative of fatigue failures, and again this correlates well with the results of macroscopic examinations shown in table III.

Fracture edge appears both transcrystalline and intercrystalline. An intercrystalline crack is formed at leading edge. Microexamination indicates stress-rupture followed by fatigue failure, whereas macroexamination indicates fatigue.

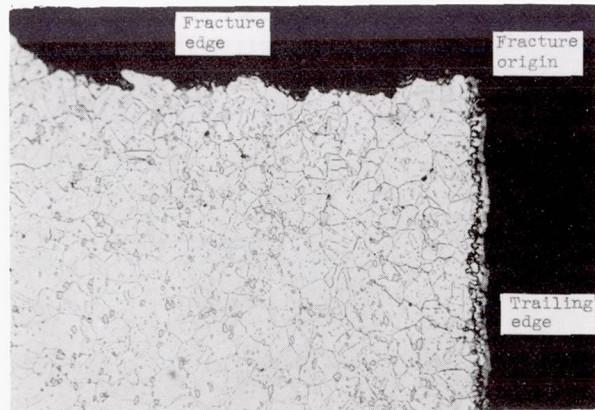
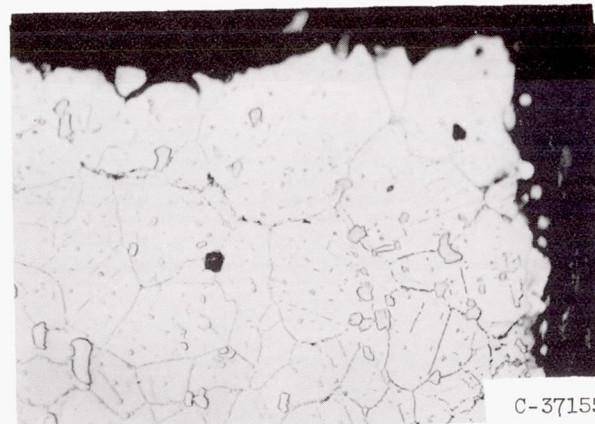
Last blade to fail, 151 hr

Fracture edge is smooth and transcrystalline.

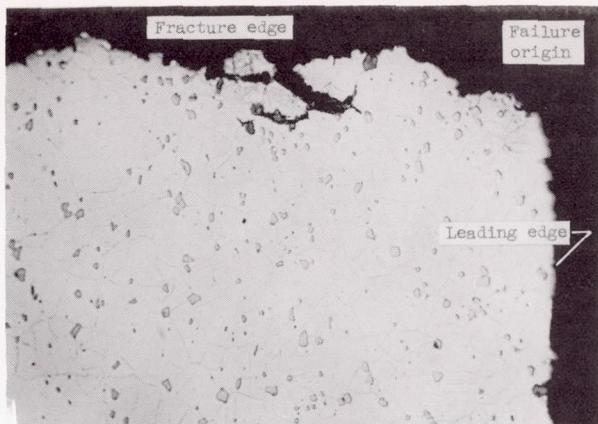
First blade to fail, 86 hr

Stress-rupture characteristics are evident in the photomicrographs of figure 8(i), which represent the blades overaged at 1900° F. The grain boundaries contain a large amount of spheroidized carbides, and in general the spheroids in these specimens are the largest of any of the heat-treated groups. Matrix precipitation (of the salt and pepper type) is not evident in either of the blade structures, but this type of precipitation is frequently difficult to see when large quantities of spheroidized particles are present.

Jaggedness and intercrystalline characteristics at and near origin of fracture indicate that fracture originated by stress-rupture. However, this is a borderline case and could be a pure fatigue failure. Fatigue characteristics occur in the left-hand portion of the photograph.

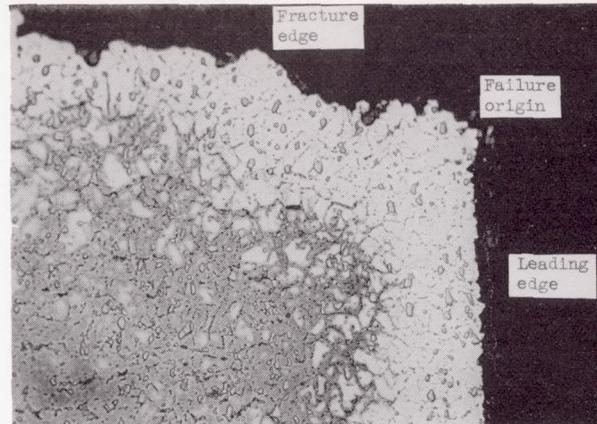
Last blade to fail, 207 hr

Fracture edge appears transcrystalline, but small tears within specimens are indicative of stress-rupture. The structure has been stained differentially, but this does not obscure detail.

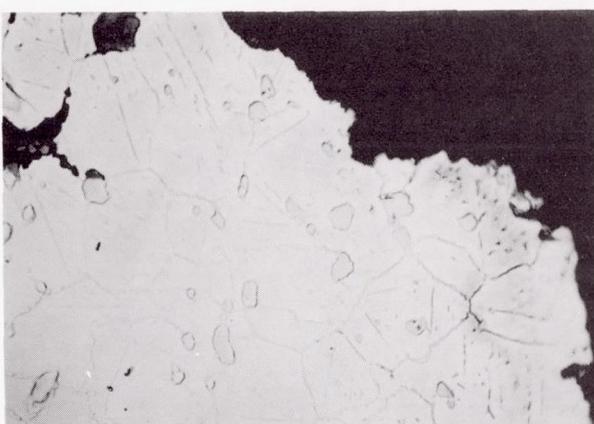
Thick grain boundary precipitation and very little general or matrix precipitation.
